**LEESBURG BOARD OF ARCHITECTURAL REVIEW  
STAFF REPORT**

**WORK SESSION: 3 DECEMBER 2012  
AGENDA ITEM 6b**

**BAR Case No. THLP-2012-0114, TLHP-2012-0115, TLHP-2012-0116 and TLHP-2012-0117: Construction of porch roof and gazebo, installation of two signs and exterior painting for King's Tavern & Wine Bar**

**Reviewer:** Kim K. Del Rance, LEED AP  
**Address:** 19 S. King St.  
**Zoning:** B-1, H-1 Overlay District  
**Applicant/Owner:** Fabian Saeidi, King's Tavern & Wine Bar

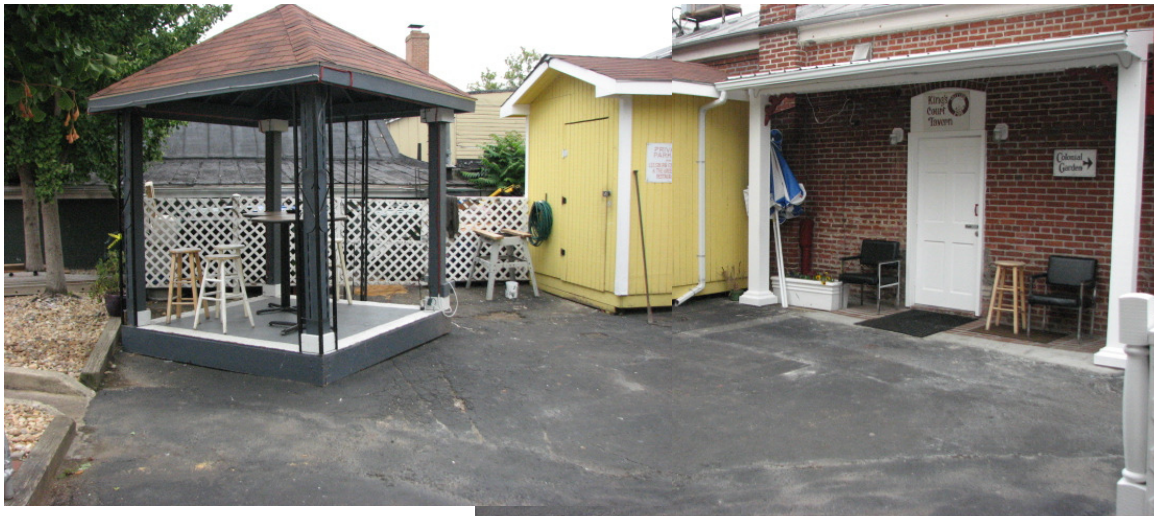
July 2008 photo (Bella Luna)

**TLHP-2012-0114:** Porch roof on rear of building with new light fixtures and new gazebo added in back lot with plastic fence and shed attached to rear of building. Altering of window muntins on front storefront glass.

- The porch roof will be reroofed with a standing seam metal roof to match the existing roof on the primary structure
- The gazebo will be removed and the plastic lattice will be replaced with a simple wood fence to be approved by staff under the normal administrative review process.
- The lighting fixtures will be replaced with suitable fixtures to be approved by staff under the normal administrative review process.

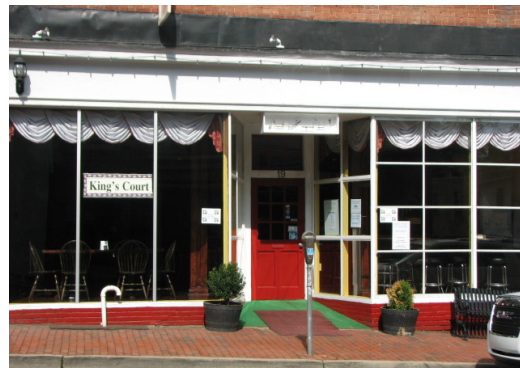
October 2012 photo (now King's Court)

The existing storefront windows had been symmetrical in their muntin placement both vertically and horizontally. Currently they do not match in either direction as the left storefront is divided vertically into three (3) segments and the right storefront is divided vertically into two (2) and then subdivided in two again with smaller muntins. Horizontally, the left storefront has no divisions, but the right has four (4) divisions. The current proportions of the storefront muntin divisions are not appropriate to be mismatched. The left storefront should be made to match the right storefront with additional muntins added back onto the glass.

- Plastic lattice is not a traditional fence material both as a material and as a pattern for fences
- The left storefront is no longer symmetrical with the right storefront glass

- The muntins will be restored to the left storefront to match the right storefront and regain its symmetry
- All applicable Town and County Zoning and Building Permits must be obtained prior to proceeding with work

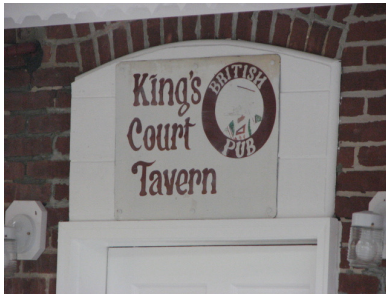
Wall sign above back door under new porch roof

- The existing wall sign placement is above a door which is not appropriate unless the Board finds it can be designed to fit into the architectural space

Staff recommends removal of the window sign and approval of **TLHP-2012-0115** for the wall sign to be lowered to the side of the rear entry door or redesigned to fit into the space above the door.

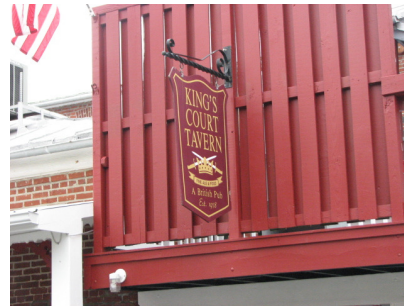
Projecting sign at back next to new porch roof

- The existing projecting sign placement on the rear deck is not at the entry door as is appropriate

Staff recommends approval of **TLHP-2012-0116** for the projecting sign to be moved to the front entry door.
